# Construction Fumes Enter Nurses' Area Through Expansion Joints

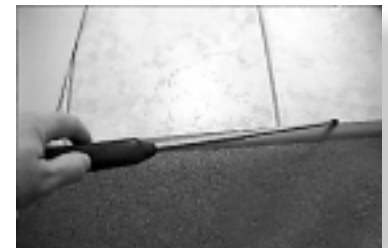
The average background UFP reading, taken at ground level and upwind of the hospital, was 9,400. On the second floor, the UFP levels in supply air and adjoining work areas were 562 and 550, respectively. The average reading in the nurses' area was 14,200—nearly 30 times greater than the surrounding areas.

Additional investigation of the nurses' area revealed a UFP level of 158,000 coming in through a floor expansion joint directly above the first-floor construction area. Despite careful planning and controls, construction fumes were migrating to the second floor through this unexpected pathway because of a pressure differential between the spaces.

Once the floor expansion joint was identified as a UFP pathway, building maintenance quickly applied a temporary seal of duct tape to block air movement. The P-TRAK confirmed the effectiveness of this measure when UFP levels dropped to those of surrounding areas. The nurses' complaints ended immediately, and the tape was left in place until the construction was finished.
