# Intermittent Headaches Tracked to Hospital's Loading Dock Activity

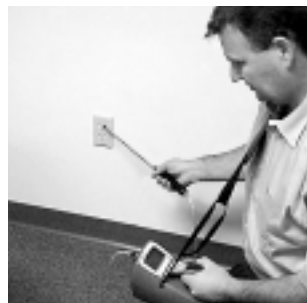
The investigation then focused on the doctor's office. Using the P-TRAK, maintenance quickly discovered UFP concentrations as high as 15,400 at an AC wall outlet. After covering the outlet with duct tape, the UFP reading in that office quickly dropped to match the adjacent offices.

Knowing that the electrical outlet was the source of the UFPs, building maintenance examined the building blueprints and found that the electrical conduit from the doctor's office led to a junction box, which then connected to a conduit that led to the loading dock. The early morning complaint could be easily correlated to vehicle activity in the loading dock. Maintenance sealed the ends of the conduits and the doctor's complaints ended.
